**Flood Control Project Maintenance
Levee Inspections**

Maintenance Issue Types Only, Levee Inspection Report By Mile - Spring 2019

Reclamation District No. 0554 Walnut Grove

Waterway	Bank	Unit Miles	Inspection Start/End	Inspector
Unit No. 01 Sacramento River	Left	1.13	03/15/2019 03/15/2019	David Julian

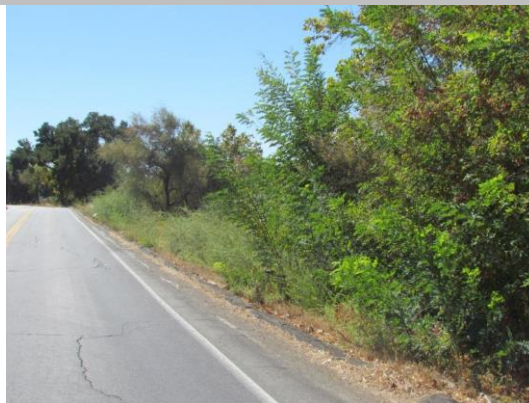
Photo 1 of 1 : SP_2019_RD0554_176_31_20190311_00010.jpg

LM Start	0.02	Rating **	M	Issue No.	31
LM End	0.17	Issue Type +	Ma	Location *	WS
Category	Earthen Levee			GPS Latitude/Longitude	
				Start	End
Item	Vegetation			38.249449 °	38.247375 °
				-121.510017 °	-121.509990 °
DWR ID	DWR_RD0554_01_f_2016_31				
Comment Code					
V2 : Remove the wild growth other than native grasses from the levee slopes.					
Inspector Comment					
Remove/reduce wild growth on the waterside to 20 feet from the crown.

Looking downstream waterside levee slope from levee mile 0.08-0.30.

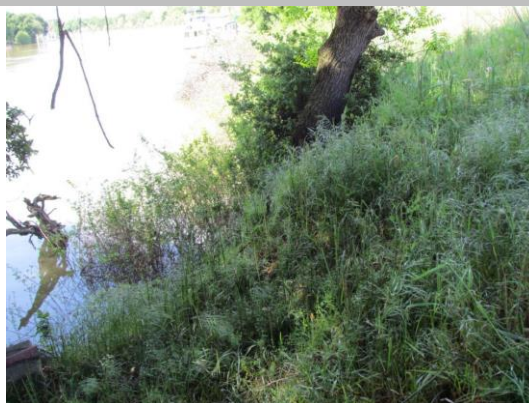
Photo 1 of 1 : SP_2019_RD0554_176_11_20190311_00001.jpg

LM Start	0.10	Rating **	M	Issue No.	11
LM End	0.10	Issue Type +	Ma	Location *	WS
Category	Earthen Levee			GPS Latitude/Longitude	
				Start	End
Item	Erosion / Bank Caving			38.248262 °	38.248262 °
				-121.509901 °	-121.509901 °
DWR ID	DWR_RD0554_01_s_2014_11				
Comment Code					
E1 : Note and monitor erosion site.					
Inspector Comment					
This is not a new erosion site, repairs are needed. One tree has fallen into the Sac River at the erosion site. This site can be seen better from the river by boat. The wild grapes block the view from the waterside shoulder looking down the slope. Rated as M because it is an oversized levee section.

RD 554 Waterside levee slope erosion into the bank, the wild vegetation growth blocks the view.

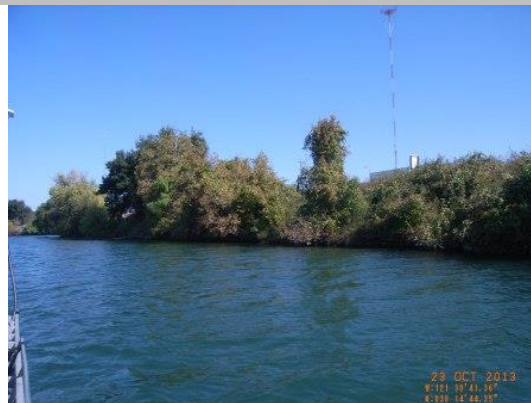
Photo 1 of 2 : SP_2019_RD0554_176_24_20190311_00005.jpg

LM Start	0.26	Rating **	M	Issue No.	24
LM End	0.36	Issue Type +	Ma	Location *	WS
Category	Supplemental			GPS Latitude/Longitude	
				Start	End
Item	2017 USACE Erosion Survey, DRAFT			38.246222 °	38.245017 °
				-121.510878 °	-121.511740 °
DWR ID	DWR_RD0554_01_f_2018_24				
Comment Code					
Inspector Comment					
2017 Site ID: SAC 27.0 L					
Status: Eroding					
2017 Field Notes: Minor new erosion at toe.					
Site History: 2009 - Tension cracks on road on top of levee. Erosion into the levee slope and mass failure. 2013 - Short vertical sections at bank toe.

USACE 2013 Photo #1

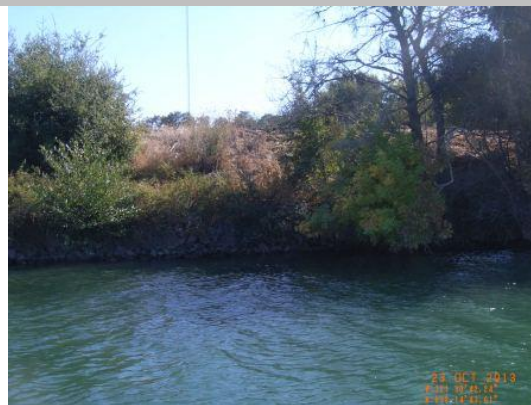
Photo 2 of 2 : SP_2019_RD0554_176_24_20190311_00006.jpg

LM Start	0.26	Rating **	M	Issue No.	24 (cont)
LM End	0.36	Issue Type +	Ma	Location *	WS

USACE 2013 Photo #2

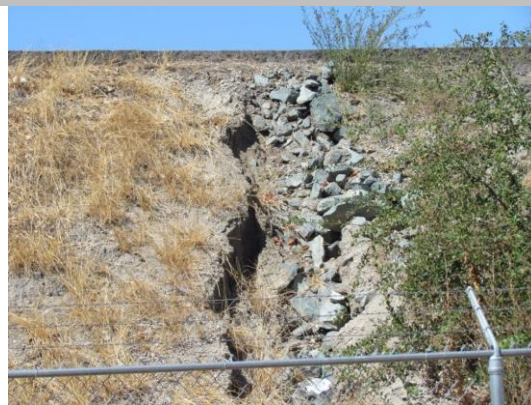
Photo 1 of 3 : SP_2019_RD0554_176_13_20190311_00002.jpg

LM Start	0.32	Rating **	U	Issue No.	13
LM End	0.32	Issue Type +	Ma	Location *	LS
Category	Earthen Levee			GPS Latitude/Longitude	
				Start	End
Item	Erosion / Bank Caving			38.245389 °	38.245389 °
				-121.511085 °	-121.511085 °
DWR ID	DWR_RD0554_01_s_2014_13				
Comment Code					
E2 : Schedule repair of erosion site prior to the next inspection.					
Inspector Comment					
This erosion isn't repaired to date. Large bush growing in eroded gully. Needs repairing. Update photos during Fall 2019 inspection.

This erosion along the landside levee slope is not new, it was reported two years ago.

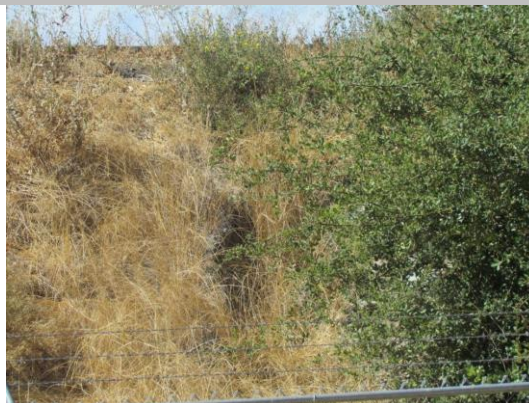
Photo 2 of 3 : SP_2019_RD0554_176_13_20190311_00003.jpg

LM Start	0.32	Rating **	U	Issue No.	13 (cont)	
LM End	0.32	Issue Type +	Ma	Location *	LS	
Category	Earthen Levee			GPS Latitude/Longitude		
				Start		End
Item	Erosion / Bank Caving			38.245389 °		38.245389 °
				-121.511085 °		-121.511085 °
DWR ID	DWR_RD0554_01_s_2014_13					
Comment Code						
E2 : Schedule repair of erosion site prior to the next inspection.						
Inspector Comment						
This erosion isn't repaired to date. Large bush growing in eroded gully. Needs repairing. Update photos during Fall 2019 inspection.

This erosion site along the landside slope levee 0.32 has been reported and has not been repaired.

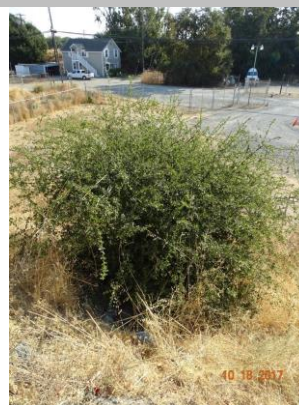
Photo 3 of 3 : SP_2019_RD0554_176_13_20190311_00004.jpg

LM Start	0.32	Rating **	U	Issue No.	13 (cont)
LM End	0.32	Issue Type +	Ma	Location *	LS

This erosion is not repaired to date. Large bush growing in eroded gully. Needs repairing.

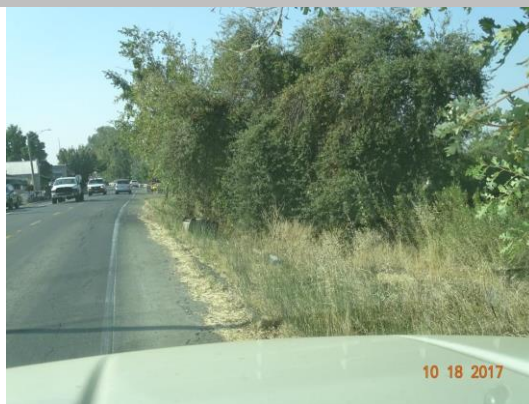
Photo 1 of 1 : SP_2019_RD0554_176_32_20190311_00011.jpg

LM Start	0.45	Rating **	M	Issue No.	32
LM End	0.49	Issue Type +	Ma	Location *	WS
Category	Earthen Levee			GPS Latitude/Longitude	
				Start	End
Item	Vegetation			38.243818 °	38.243389 °
				-121.512459 °	-121.512919 °
DWR ID	DWR_RD0554_01_f_2017_32				
Comment Code					
V2 : Remove the wild growth other than native grasses from the levee slopes.					
Inspector Comment					
Waterside vegetation should be cleared to 20 feet from crown for inspection and access.

View of waterside vegetation

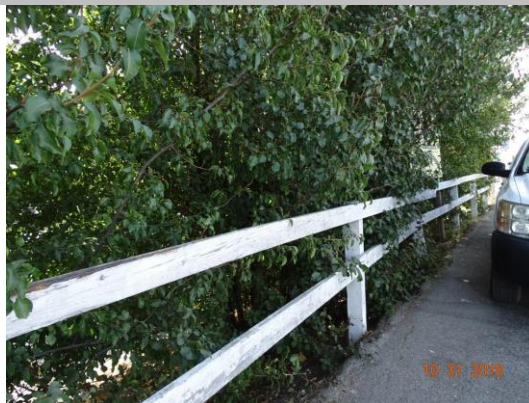
Photo 1 of 1 : SP_2019_RD0554_176_25_20190311_00007.jpg

LM Start	0.58	Rating **	U	Issue No.	25	
LM End	0.58	Issue Type +	Ma	Location *	LS	
Category	Earthen Levee			GPS Latitude/Longitude		
				Start		End
Item	Trim / Thin Trees			38.242268 °		38.242268 °
				-121.513802 °		-121.513802 °
DWR ID	DWR_RD0554_01_f_2018_25					
Comment Code						
T2 : Thin trees to allow visibility of the ground and room to flood fight.						
Inspector Comment

View of thick trees on the landside slope (October 2018)

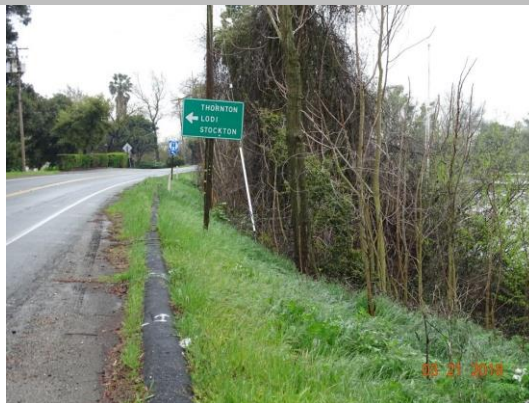
Photo 1 of 1 : SP_2019_RD0554_176_37_20190311_00012.jpg

LM Start	1.00	Rating **	M	Issue No.	37
LM End	1.13	Issue Type +	Ma	Location *	WS
Category	Earthen Levee			GPS Latitude/Longitude	
				Start	End
Item	Trim / Thin Trees			38.236991 °	38.235232 °
				-121.516812 °	-121.517341 °
DWR ID	DWR_RD0554_01_s_2017_37				
Comment Code					
T2 : Thin trees to allow visibility of the ground and room to flood fight.					
Inspector Comment					
Thin out the trees and remove the wild growth blocking view of the levee section.

Trees on waterside should be thinned and trimmed to allow inspection and access.
